**Capacitec**

| DWG SIZE: <b>A</b> | DRAWING TITLE: <b>GPS-4.5(.012)-A-450-5509-9185</b> | |
| SERIES NO: | DRAWING NO: <b>5509-9185-SD</b> | |

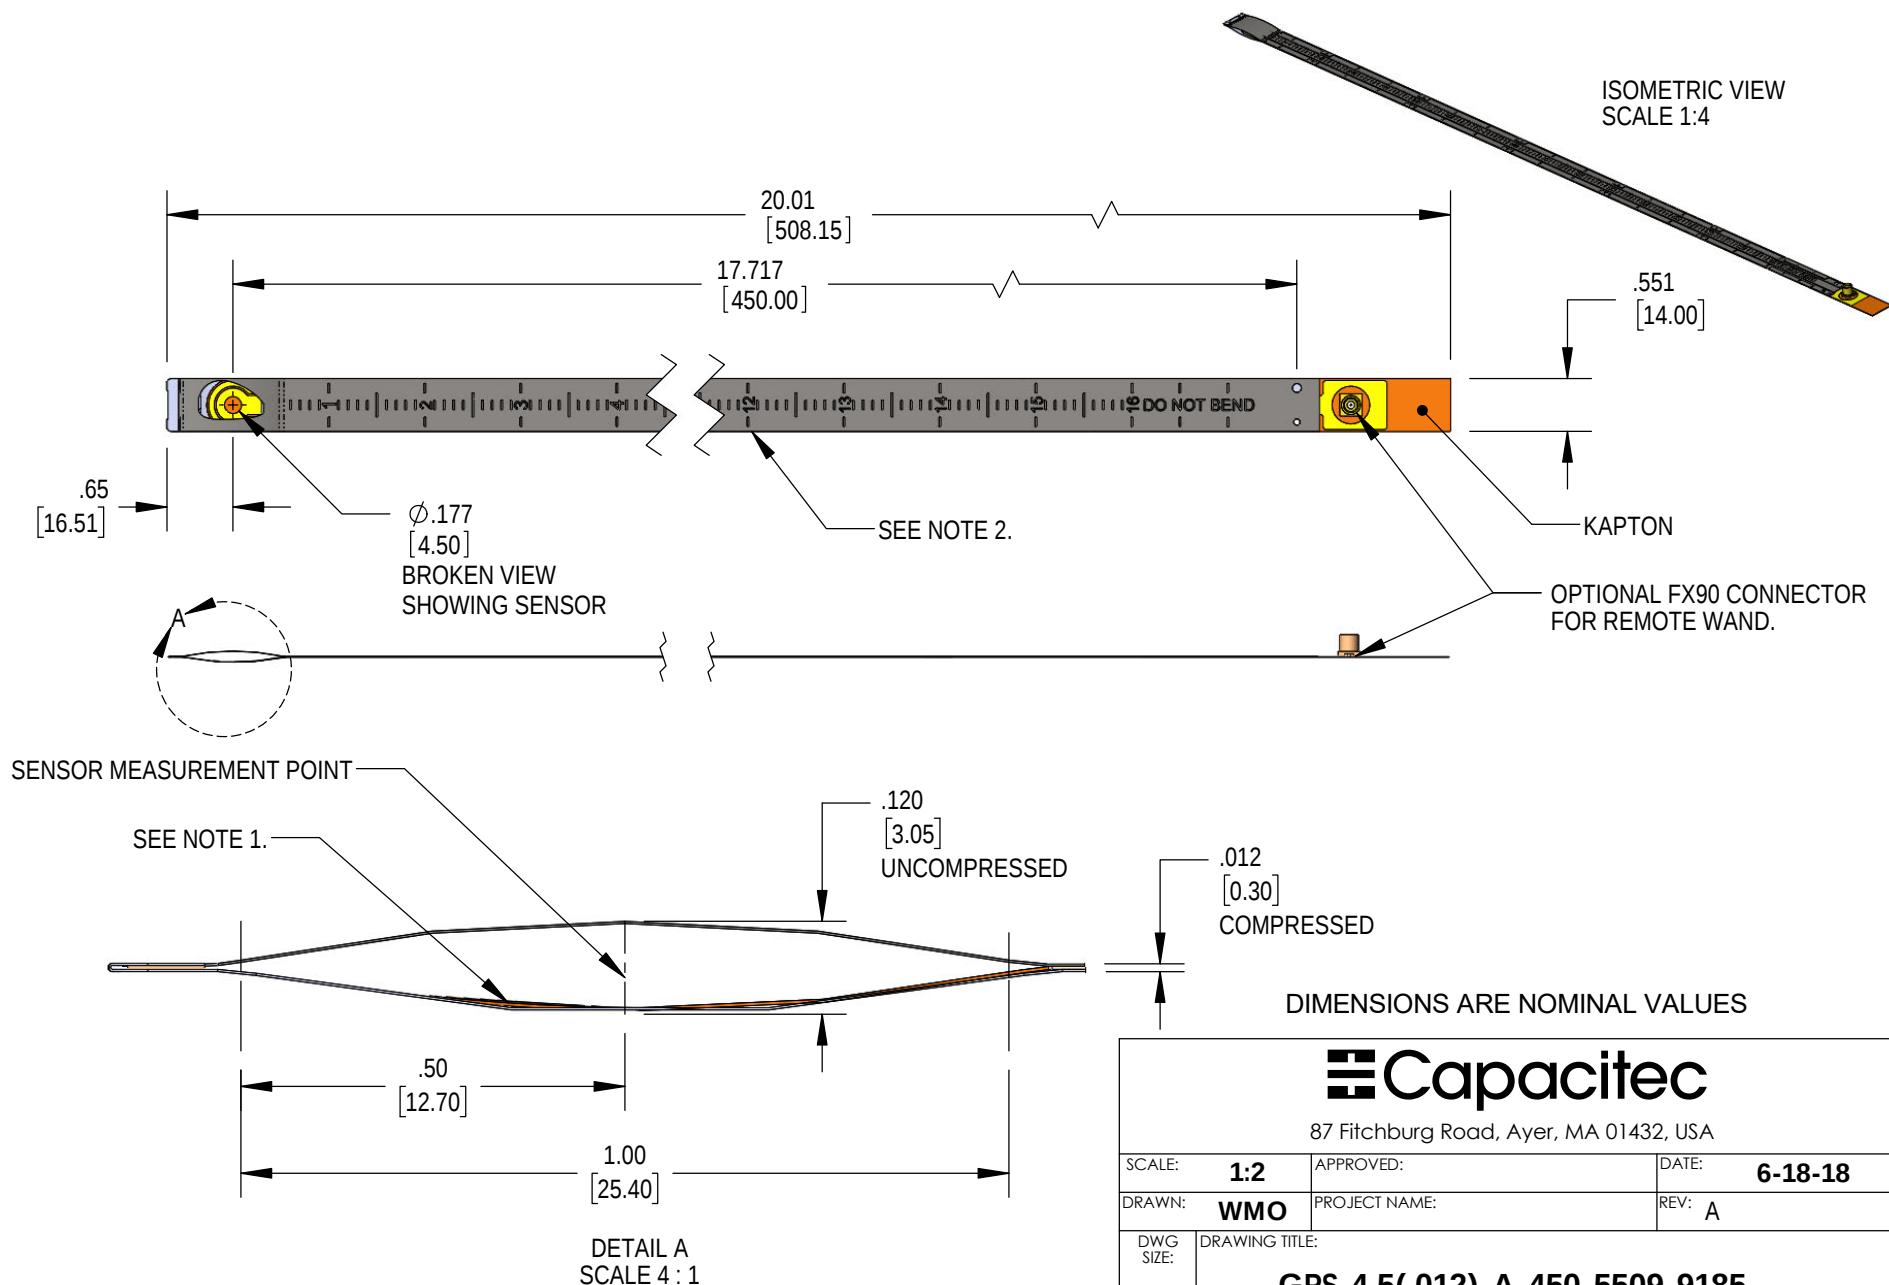
SHEET 1 OF 2

1. WAND INCLUDING SENSOR BONDED TO THE BOTTOM SHIM.
2. WELD REINFORCEMENT SHIM LOCATIONS (BOTH SIDES).

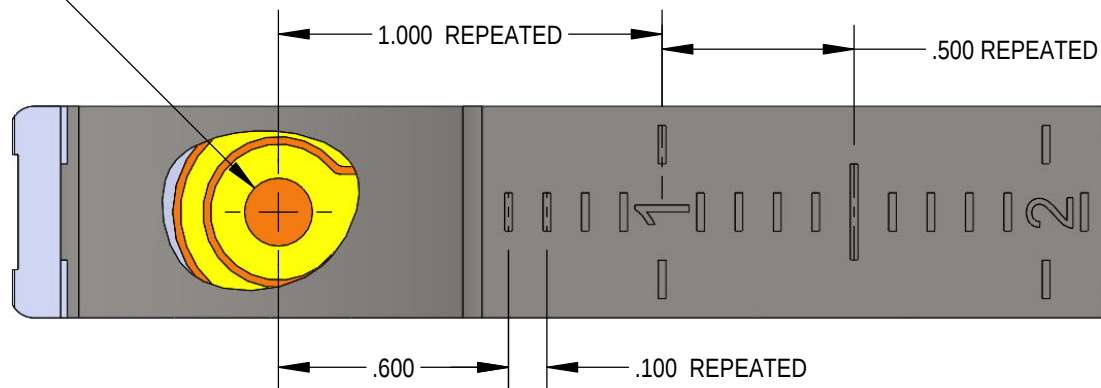
$\phi .177$   
 [4.50]  
 BROKEN VIEW  
 SHOWING SENSOR

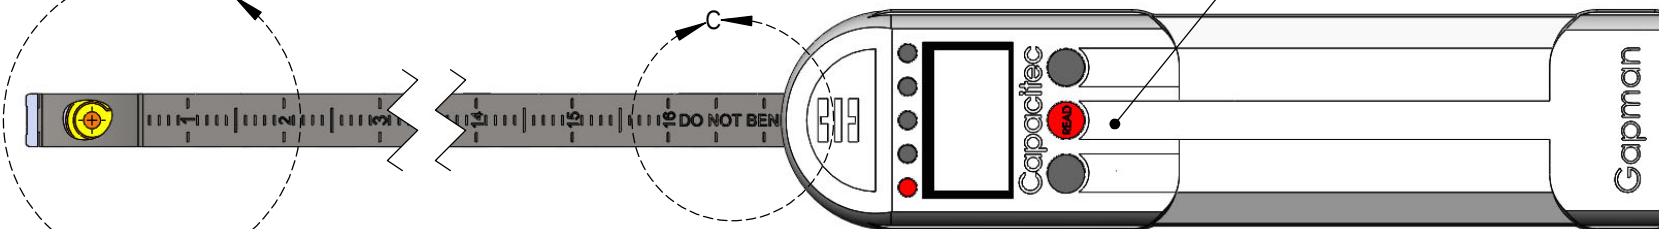
GAPMAN 4200-GM-GEN 3  
 ORDER SEPARATELY  
 SEE DRAWING 5534-7819-SD
